Bude Canal Regeneration Project

Article by **Charlie David**, Public Space Manager

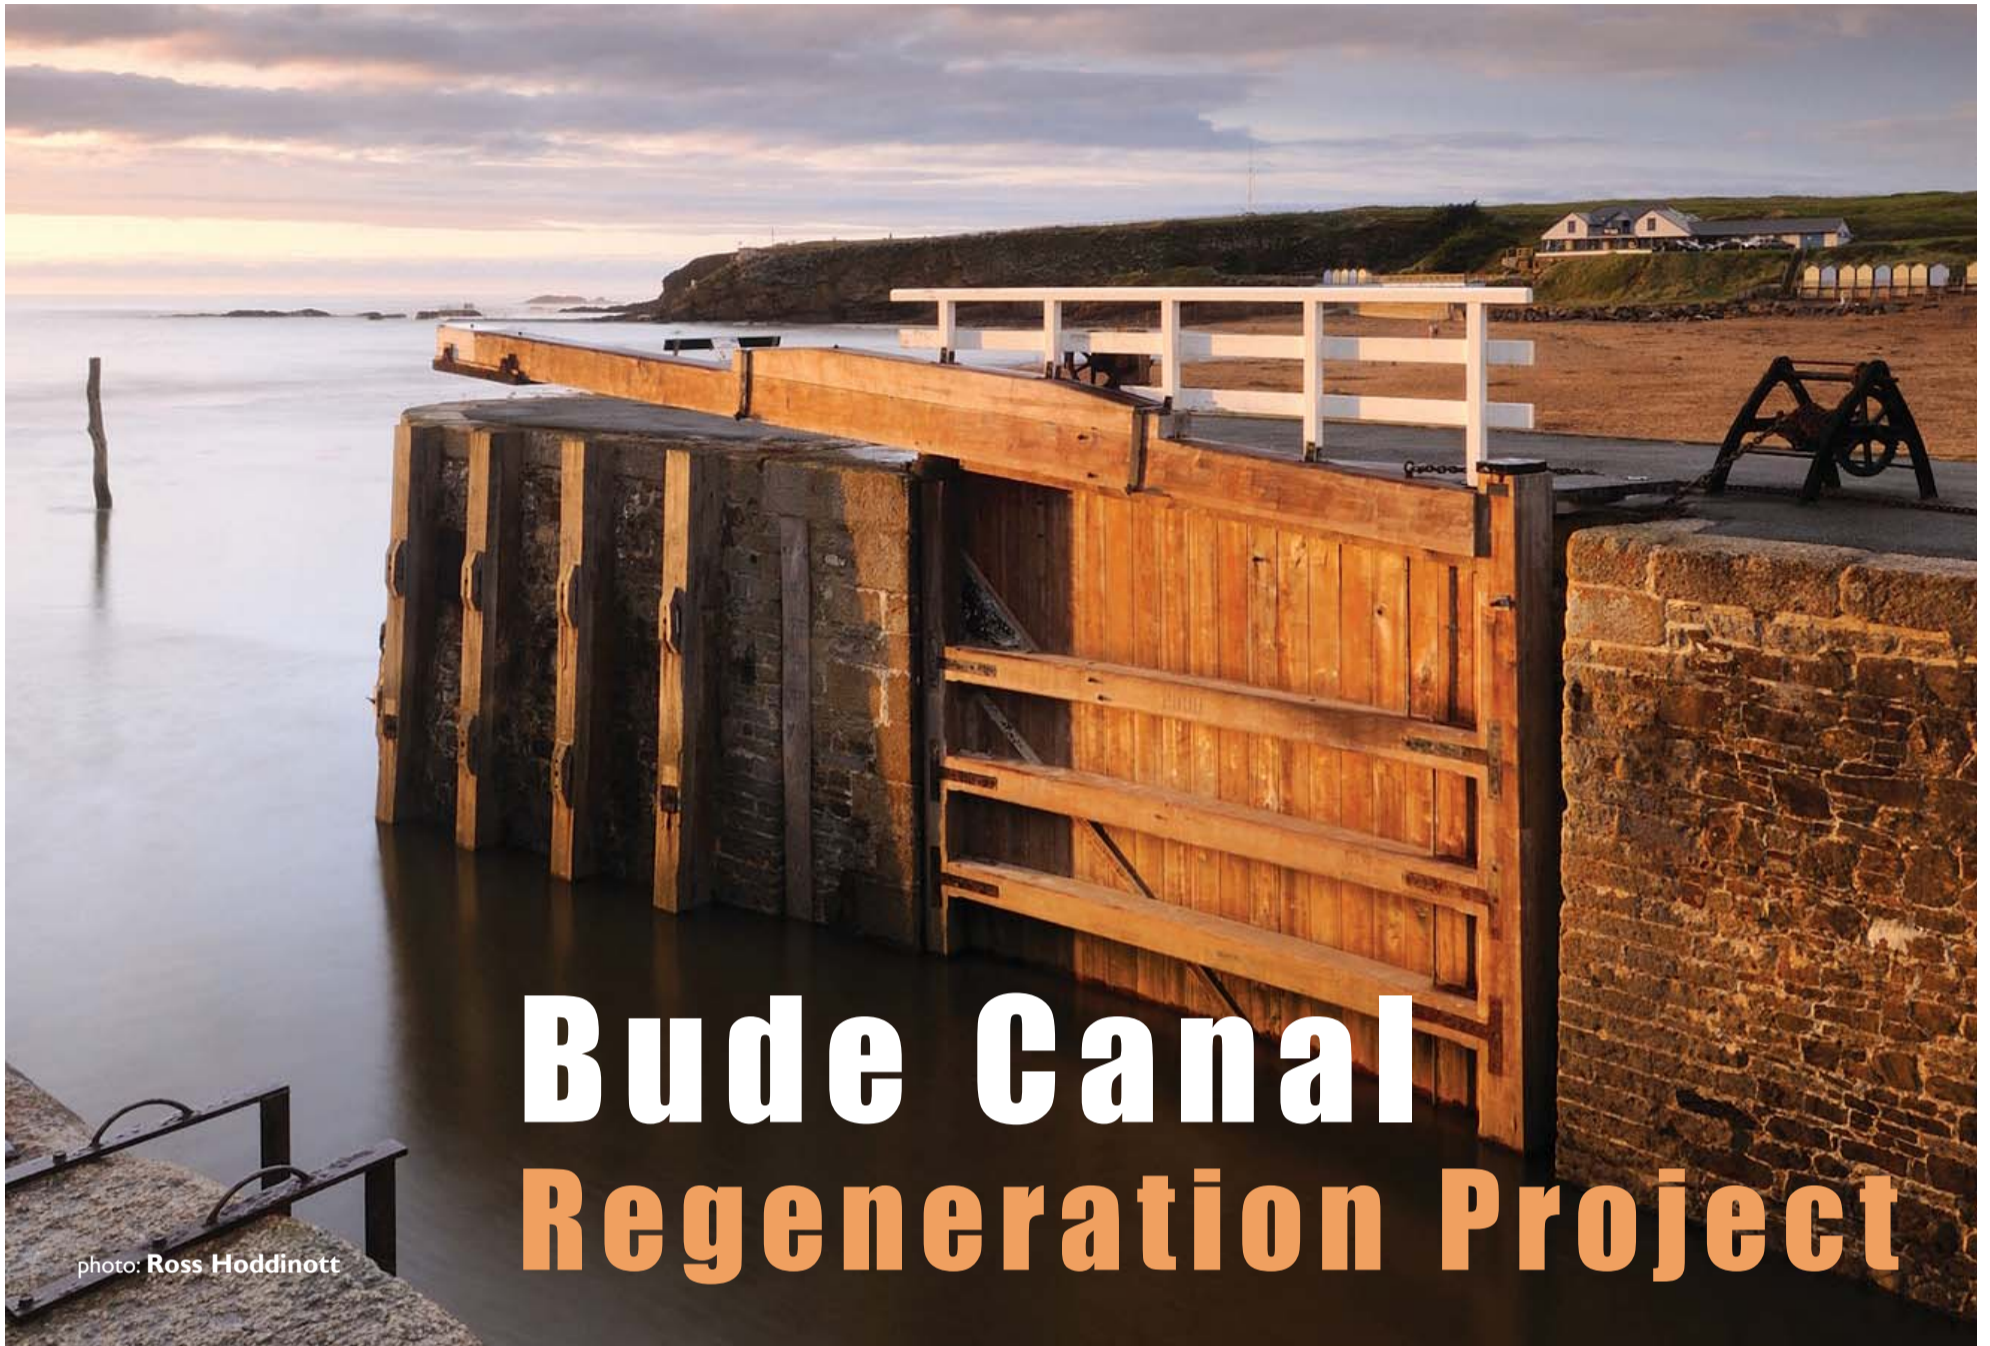
above: **Bude's lock gates** were replaced in 2001 after a service of over 180 years. Built as part of the Bude Canal in 1819, it is a rare example of a canal connecting directly with the sea.
